## IMPROVEMENT OF EXHAUST TEMPERATURE DISTRIBUTION DURING COMMISSIONING OF GAS TURBINE

**Abstract-** During the commissioning of the gas turbine (GT) AE64.3A operated with fuel oil, some problems relevant to the EGT distribution and the very high fuel oil pressure were detected, when switching from diffusion to premix mode. The combustion of fuel oil is a very sensitive issue because it is affected by a lot of internal and external variables. This article aims to show how the problems were addressed and solved and the tools that were used to analyze them. The problems were caused because some burners were clogged for an unknown reason and the GT tripped every time due the high spread of EGT. For analyzing the temperature distribution, the EGT profile was built up, using the data taken from the 24 thermocouples installed in the combustion chamber of the GT and some simulations were performed using the MATLAB. Through the Performance Monitoring, DCS module was evaluated the performance of the GT when the EGT spread was higher than the threshold and was found that the fuel oil consumption was increased. Under investigation was taken the quality of fuel oil and demineralized water (in

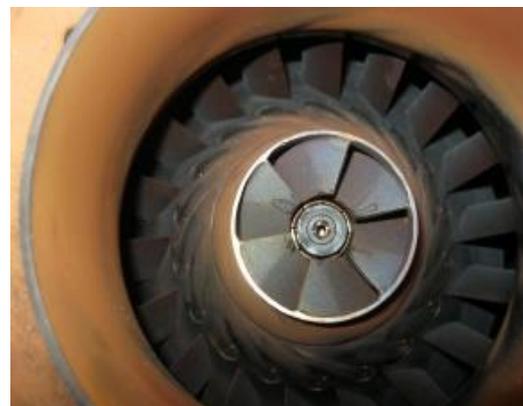
Figure 5. Premix oil burner

In particular, each premix oil burner is constituted by 18 nozzles of a very small diameter (approximately 0.5 mm) to achieve good atomization (Figure 5).

Due to this small diameter, it must always be ensured that the oil supplied is properly cleaned and there is no trace of impurity inside the piping, to avoid any risk of clogging which may cause cracking of the injected fuel and finally the complete damage of the nozzles.

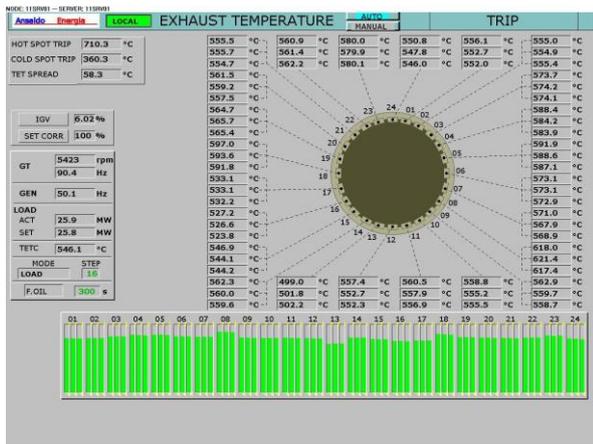
Figure 6. Nonhomogeneous exhaust temperature

Before the start-up, the piping has been flushed and the microfilters on the connection between the fuel oil collector and the burners have been installed. Nevertheless, it was found that the exhaust temperature associated with some burners was slightly lower than the average and on the other hand, some other burners were burning more fuel to compensate. For example consider Figure 6.

It can be seen that at approximately 26 MW the exhaust temperature distribution shows some difference between thermocouples.

To improve this distribution, it has been executed a "backflow" of the pre-mix burners, by pressing the air at the compressor outlet (approx. 10 bar) to the collector through the nozzles [4]. Thanks to this operation a large part of impurities has been removed from the burners and the piping. The following temperature distribution was much better, even at the maximum load.

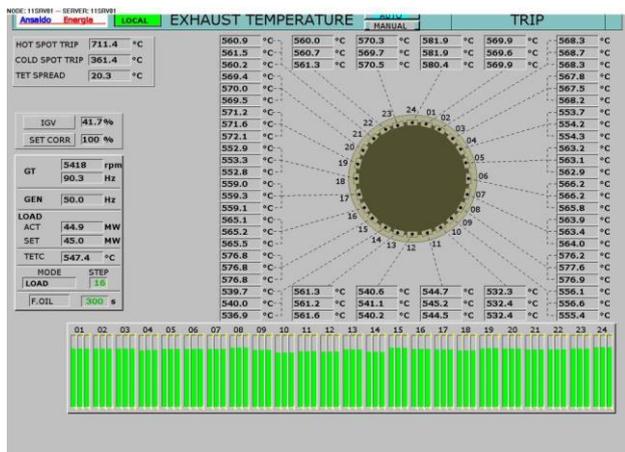
Figure 7. Uniformization of the exhaust temperature

After these activities the engine has been started and operated in pre-mix mode, the exhaust temperature distribution was more uniform, Figure 7.

Immediately after the replacement of the pre-mix oil burners the turbine exhaust distribution results improved. The clogging of the existing burners was probably due to the exposure of the fuel oil nozzles to impurities during the long standstill.

During the combustion chamber inspection, the cleanliness of the burners has been checked and it was decided to replace two burners (number 14 and 18). The burner's cleanliness was checked by the flow test. Simultaneously the microfilters installed on the piping were removed to allow a more efficient backflow at the following change over to pre-mix operation.

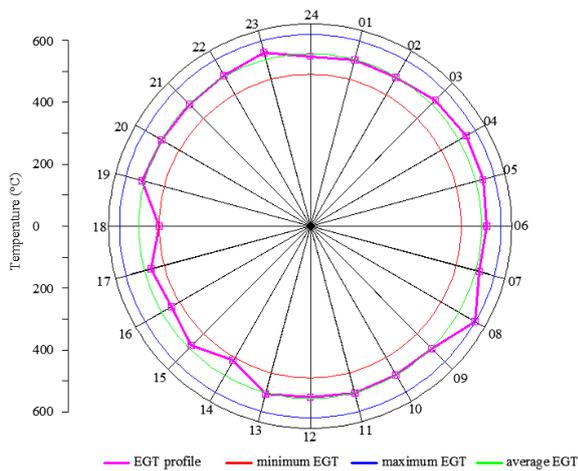
Figure 8. EGT profile

It was found that the exhaust temperature associated with some burners was lower than the average and on the other hand, some other burners were burning more fuel to compensate. The temperature profile is shown in Figure 8.

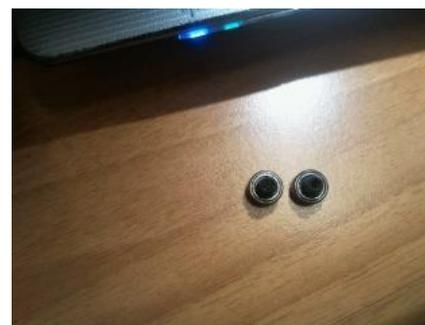
Figure 10. Clogged nozzles

During the outage, the sealing air valve, the drains and, the fuel oil lines have been inspected to search for any anomaly or leakage to explain the clogging of the nozzles. Furthermore, the purging sequence has been analyzed once again but all the steps appeared to be configured properly. From the combustion chamber the nozzles appeared clean without any trace of cracking outside the nozzles, the occlusion is therefore inside the nozzles from the annulus connection.

In Figure 10 are shown two nozzles extracted from burner 18 and it can be seen that the internal part of the nozzles is filled with residual from oil.

- 1) The analysis of the events shows evidence that the deposit on the nozzles takes place after the shutdown, due to the warming of the burners and residual presence of fuel oil film inside the burners.

The nozzles have been cleaned once again and some other modifications to the purging sequence – in particular, the opening of the drains prolonged and the fuel oil premix nozzles back purging automatically started at 15 MW and 3 minutes after the switchback.

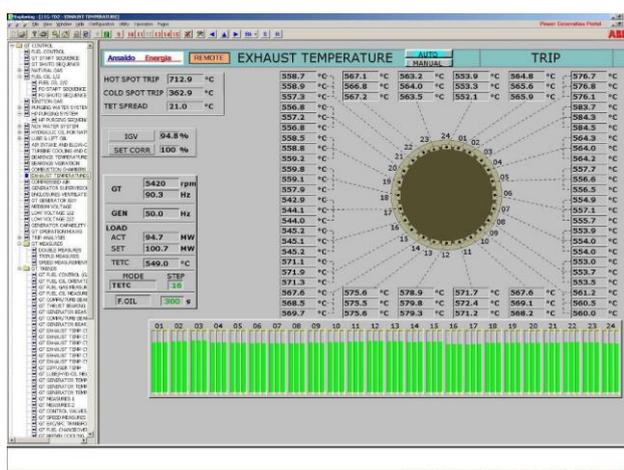
Figure 12. Exhaust temperature distribution at baseload

After the above tests are carried out, the gas turbine was started up and at the fuel oil premix connection, the condition of the burners appeared very good. The plant has been set to baseload for the rest of the day. At base load, the situation is shown in Figures 11 and 12:

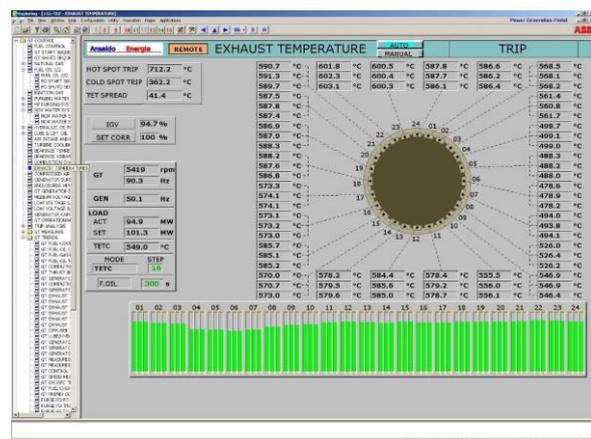
Figure 14. The temperature spread in the GT burners

After some back purge the premix oil has been connected again and this time the pressure was around the normal values (slightly higher). When the plant reached the baseload, the spread was higher than before but still on acceptable values. Furthermore, the lower temperature is found on adjacent thermocouples, this means that the anomaly is only on one or two burners. Figure 14 shows the situation of the temperature spread in the burners.
