## IMPROVEMENT OF EXHAUST TEMPERATURE DISTRIBUTION DURING COMMISSIONING OF GAS TURBINE

**Abstract-** During the commissioning of the gas turbine (GT) AE64.3A operated with fuel oil, some problems relevant to the EGT distribution and the very high fuel oil pressure were detected, when switching from diffusion to premix mode. The combustion of fuel oil is a very sensitive issue because it is affected by a lot of internal and external variables. This article aims to show how the problems were addressed and solved and the tools that were used to analyze them. The problems were caused because some burners were clogged for an unknown reason and the GT tripped every time due the high spread of EGT. For analyzing the temperature distribution, the EGT profile was built up, using the data taken from the 24 thermocouples installed in the combustion chamber of the GT and some simulations were performed using the MATLAB. Through the Performance Monitoring, DCS module was evaluated the performance of the GT when the EGT spread was higher than the threshold and was found that the fuel oil consumption was increased. Under investigation was taken the quality of fuel oil and demineralized water (in

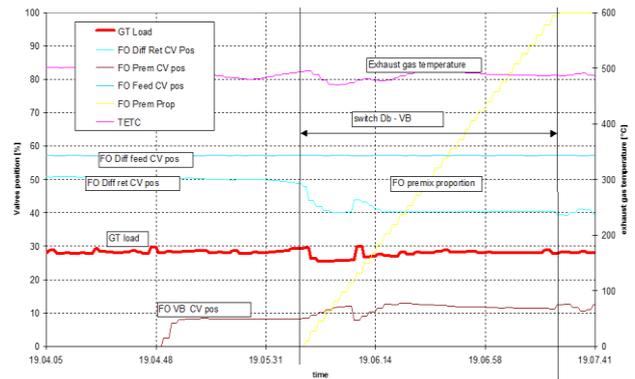
Figure 4 is taken from DCS during the operation of the GT and shows what happens with GT parameters during the changeover.

Figure 4. Change over oil diffusion to oil premix mode

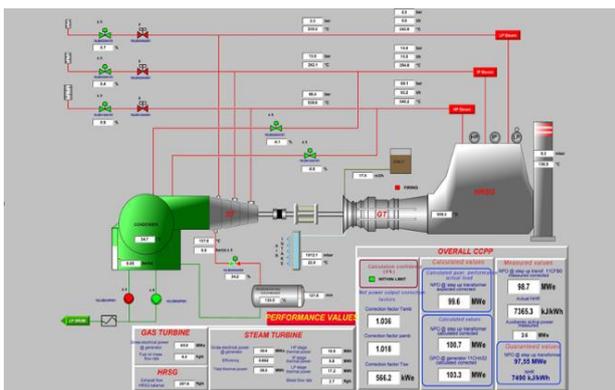
In that time was build up a CCPP Performance Monitoring DCS module [8]. The module was used to evaluate the CCPP performance and the performance of all components GT, ST and HRSG. We used this module to evaluate the performance of the GT during the operation in partial and full load when the spread of the EGT was over the default threshold. It was found that the GT global efficiency was negatively affected by the higher spread of the EGT. In Figure 9, there is a CCPP performance overview, where the GT power output and fuel oil consumption are shown.

Figure 9. CCPP performance overview

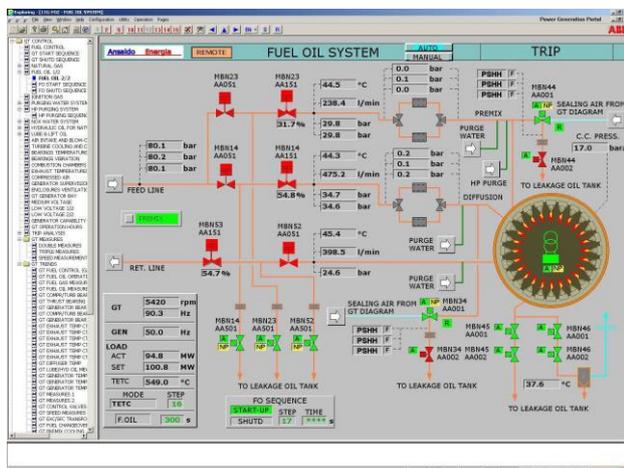
After the above tests are carried out, the gas turbine was started up and at the fuel oil premix connection, the condition of the burners appeared very good. The plant has been set to baseload for the rest of the day. At base load, the situation is shown in Figures 11 and 12:

Figure 11. Fuel oil system parameters at baseload

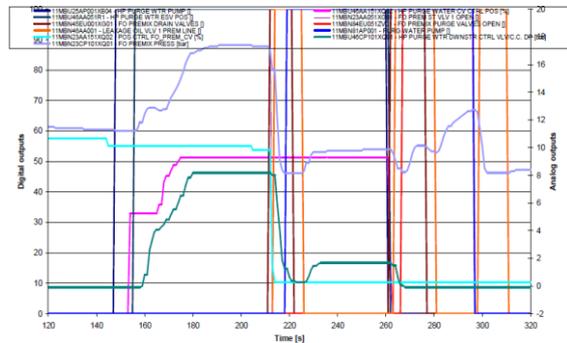
The engine has been stopped in the evening without any anomalies. In Figure 13, purging sequence is shown (data taken from Tenore™ as .csv and plotted by Excel).

Figure 13. Purging sequence of the GT
